# **Mechanical Solutions, Inc.** **Rotating Machinery Analysis, Test & Troubleshooting**

## **Case History: Aeroderivative Gas Turbine and Gearbox / Genset**

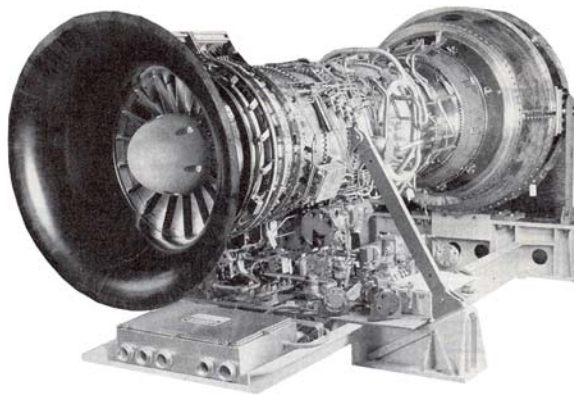
MSI was called on behalf of a customer who had seen a large increase in the vibration levels of a particular LM500 Gas Turbine Generator Set being used to supply power to a large pharmaceutical facility. The increase in vibration levels was serious enough to warrant shutdown. This power facility was used to meet much of the electrical power needs of the entire complex and any loss of generating capacity translated straight into increased electrical operating costs because of the need to buy power from the grid at a time of the year where such purchases were particularly expensive. The plant wished to continue operation another 3 months, until there was a planned shutdown.

spectrum, the strength of the vibration appeared to be associated with a natural frequency resonance. However, impulse testing on exposed components detected no strong natural frequencies near 1X or 2x gear mesh. It was also noted that the vibration increase was sensitive to load level. In light of this, the sudden increase in vibration suggested a possible shaft or casing crack that opens up under increasing load. This crack could open up further as the load transmitted through the gear box was increased. Stationary “bump” tests did not indicate this crack but vibration measurements at many locations at various loads made it apparent.

On the recommendation of MSI, die penetrant testing of the gear box was conducted. The die penetrant testing revealed that a crack had formed on the foot of the gear box casing. The crack was welded shut and subsequently the vibration of the gearbox was reduced to earlier acceptable levels. This work allowed the end user to continue power generation during a critical portion of production.
