Case History: Aeroderivative Gas Turbine and Gearbox / Genset

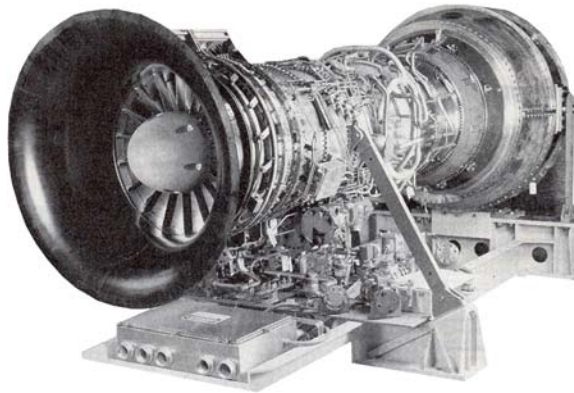
MSI was called on behalf of a customer who had seen a large increase in the vibration levels of a particular LM500 Gas Turbine Generator Set being used to supply power to a large pharmaceutical facility. The increase in vibration levels was serious enough to warrant shutdown. This power facility was used to meet much of the electrical power needs of the entire complex and any loss of generating capacity translated straight into increased electrical operating costs because of the need to buy power from the grid at a time of the year where such purchases were particularly expensive. The plant wished to continue operation another 3 months, until there was a planned shutdown.

spectrum, the strength of the vibration appeared to be associated with a natural frequency resonance. However, impulse testing on exposed components detected no strong natural frequencies near 1X or 2x gear mesh. It was also noted that the vibration increase was sensitive to load level. In light of this, the sudden increase in vibration suggested a possible shaft or casing crack that opens up under increasing load. This crack could open up further as the load transmitted through the gear box was increased. Stationary “bump” tests did not indicate this crack but vibration measurements at many locations at various loads made it apparent.

On the recommendation of MSI, die penetrant testing of the gear box was conducted. The die penetrant testing revealed that a crack had formed on the foot of the gear box casing. The crack was welded shut and subsequently the vibration of the gearbox was reduced to earlier acceptable levels. This work allowed the end user to continue power generation during a critical portion of production.
