Case History: Strain Measurement of a Centrifugal Compressor Impeller via FM Telemetry

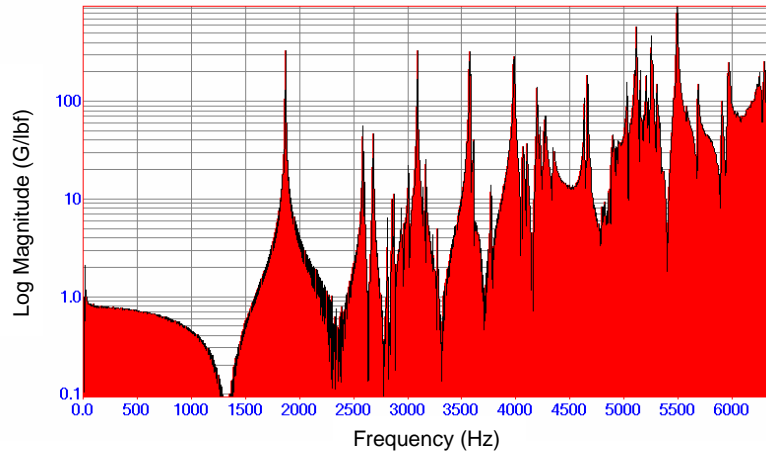
Figure 1: Natural Frequency Response of Stationary Impeller

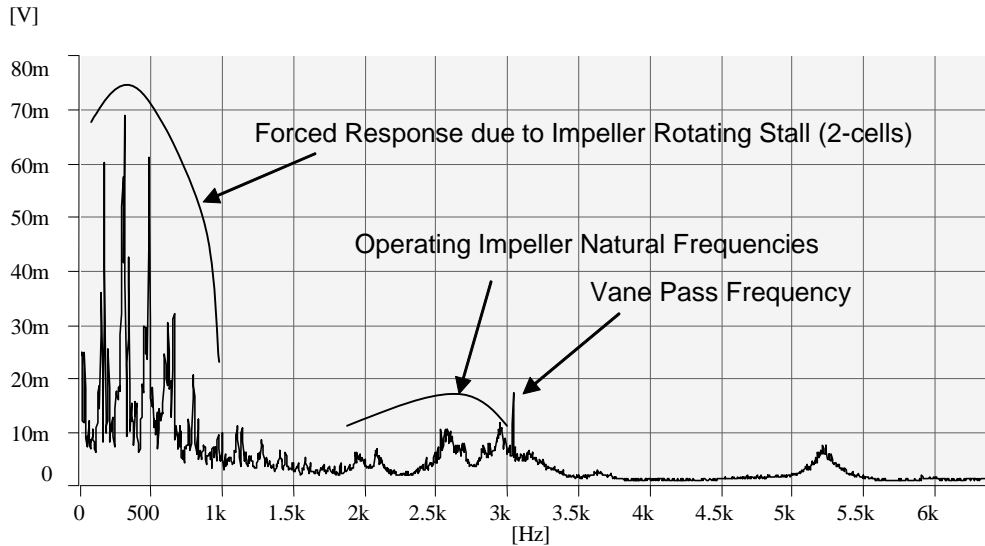
The OEM had suspected that the problematic stress would be occurring due to a natural frequency resonance close to vane pass at 3 kHz. Figure 2 shows actual output from a strain gage on the rotating impeller during testing. The natural frequency modes near 3 kHz are clearly evident since they were excited by the flow turbulence in the vicinity of the blades. However, much higher strain levels are seen at lower frequencies. Based on the testing program, MSI was able to determine that the high strain

levels at the low frequencies were forced vibration caused by rotating stall. This stall phenomenon was occurring at non-audible levels and was significant enough to cause high cycle fatigue failure. This conclusion would never have been reached if the advanced testing program put together by MSI had not been conducted.

Figure 2: Strain Gage Response of Rotating Impeller

The natural frequencies observed during testing correlated well both with stationary impact test results and predictions by MSI using 3-D finite element analysis (FEA). The analysis was then used to investigate “what-if” scenarios, to determine how strong the stall needed to be to cause fatigue and to investigate design modifications to reduce peak stresses and cracking potential. Overall, the efforts of MSI in conjunction with the OEM contributed to a successful redesign effort.
