Case History: Gear Tooth Failure Problem Resolution

MSI was contracted by the OEM to perform testing and analysis and determine the root cause of gear tooth failures on an aeroderivative gas turbine power generation drivetrain. The 37 MW gearbox had broken teeth on the pinion after several thousand hours of operation. The OEM was proceeding with a gear tooth profile re-design to make the gear more tolerant of the misalignment to which other consultants had attributed the tooth failures. The OEM was suspicious that the suspected level of gear mesh misalignment could not explain the tooth failures, but at the time there was no better explanation.

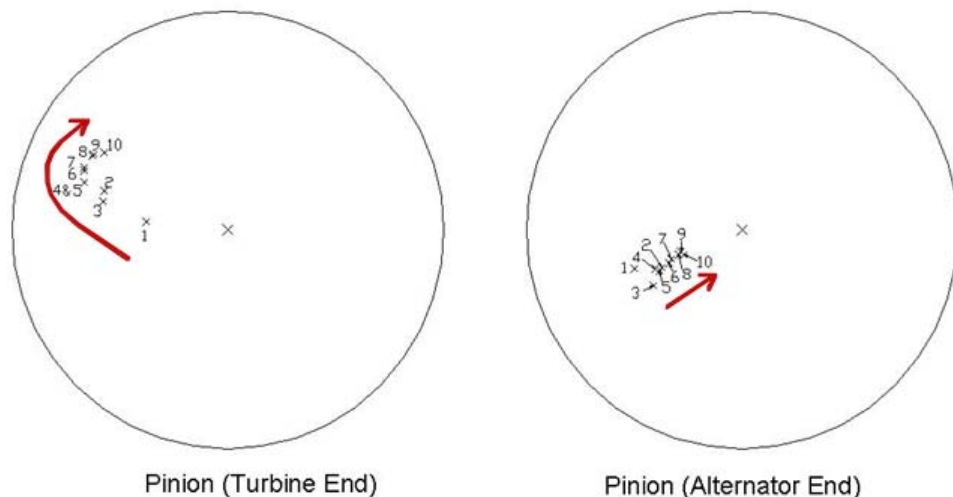
MSI's measurements at the bearing locations indicated imbalance in the radial loading of the pinion rotor from the turbine end to the alternator end. The pinion centerline (average location, not vibration) moved with increasing load as shown by the arrows in Figure 1. It is important to note that the two ends of the pinion behaved very differently, with the turbine end following a crescent shaped trajectory and the generator end gradually moving toward the centerline as the load was increased.

Figure 1: Shaft centerline position relative to the bearing centerline. The outer circle represents the bearing clearance. The arrows indicate the direction the rotor centerline moves with increasing load.

The bearing temperatures and eccentricity at the two ends of the rotor differed considerably and both indicated that the radial loading was skewed to the turbine end. In double helical gear sets, one of the elements, in this case the pinion should be free to move axially with respect to the other to equalize the tooth loads on each helix. Imbalance in the radial loading implied that there was external force acting on the pinion rotor which resulted in one of the helices carrying significantly more load. The source of this force was thermal growth of the high-speed rotor system (pinion and power turbine) exceeding the axial clearance in the coupling. The axial growth reacts at the thrust bearing of the bull gear rotor, transmitting unbalanced axial loads through the gear teeth.

The problem was corrected by increasing the axial travel of the coupling between the power turbine and the pinion. The route which the OEM was taking to redesign the gear tooth profile to account for a hypothetical gear mesh misalignment would not have solved the problem, and may have even resulted in higher tooth stress levels and more frequent failures.
