## Case History: Boiler Feed Pump Reliability Problem

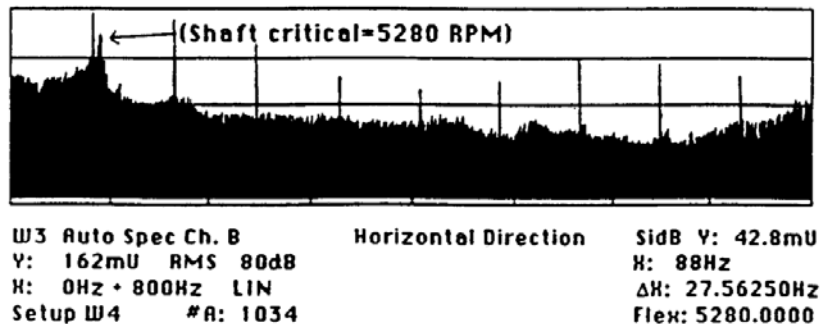
Vibration Spectrum Before Bearing Modification

Impact vibration testing using MSI’s *TAP™* technique quickly determined that one of the rotor critical speeds was far from where it was predicted to be, had dropped into the running speed range (4900-5750 RPM), and

0 - 800 Hz (0 - 48000 RPM)  
 Operating Speed = 4900 RPM

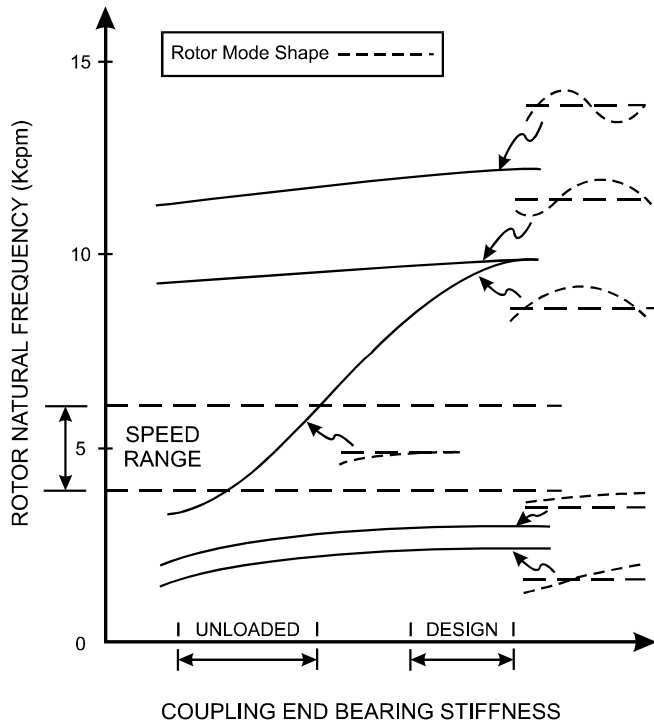
“WHAT-IF” ANALYSIS

appeared to be the sole cause of the pump’s reliability problems. “What-if” iterations with the OEM’s rotor dynamic computer model, verified with a similar model constructed by MSI engineers using ROMAC programs, showed that the particular rotor natural frequency value and rotor mode deflection shape could best be explained by improper operation of the coupling end bearing. The bearing was removed and thoroughly inspected, and was found to have a critical clearance far from the intended value, because of a drafting mistake on the bearing’s drawing, such that this mistake carried over each time the bearing was repaired or replaced. Installation of the correctly constructed bearing resulted in the problem rotor critical speed shifting to close to its expected value, well out of the operating speed range. The pump has since run

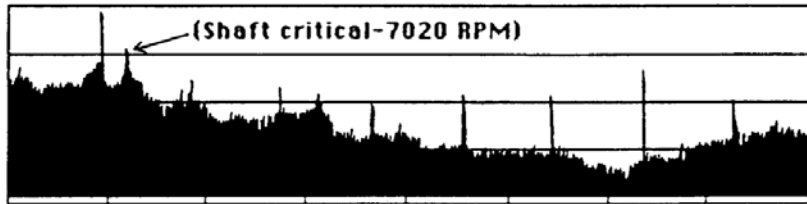
Vibration Spectrum After Bearing Modification

0 - 800 Hz (0 - 48000 RPM)  
 Operating Speed = 5750 RPM
