Case History: Hydro-cracking Pump Rotor Failures

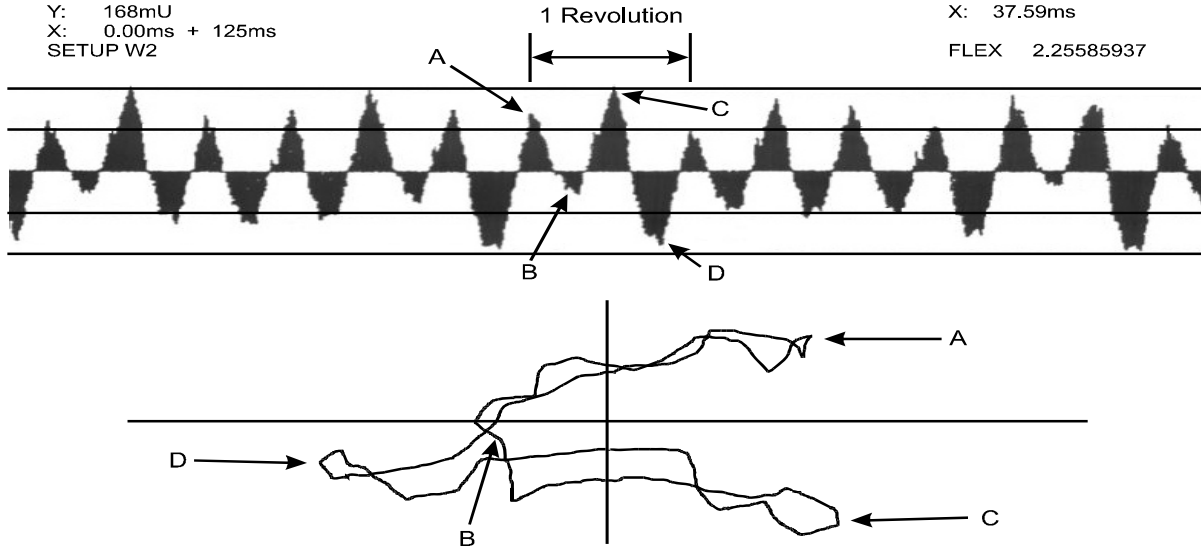
Orbit of Outboard Shaft

The testing found the critical speeds of the operating pump, and the combined testing and analysis showed that the main reason for past failures was a poorly damped backward precessional rotordynamic critical speed, which was located at a lower speed than expected. The critical speed would be excited operationally at 2x running speed during a rub of the balance piston. This was possible when pumping product with excessively low specific gravity, because of flashing of the liquid at the exit of the balance drum causing loss of a liquid film between the rotor and stator. A time-averaged pulsing

(TAP™) test performed by Msi's engineers clearly showed that a shaft "second bending" mode was near 2x running speed, and proximity probe traces showed that the orbit was made up of primarily 2x running speed vibration when the pump experienced the operational difficulties. The rotor design was changed to make this mode more difficult to excite, and the minimum permitted specific gravity was increased by the plant to a level that would avoid flashing. The pump, which had been failing roughly every three months, has now run for three years without further difficulty.
