Case History: A Cure for the Common Cold – in Turbines

A 45 MW steam turbine at waste-to-energy facility in the Northeast underwent a scheduled repair at which time the turbine bearings were reworked. After this rework, the turbine periodically experienced very high amplitude turbine shaft vibrations. This phenomenon was associated with either unexpected cold ambient temperatures or with a disrupting event in the plant (e.g. one boiler shutting down) or a sudden shift in turbine load. These events were usually followed by several hours of plant maintenance personnel working frantically to keep the turbine vibrations below the pre-set trip levels. Exceeding these levels would have shut down the turbine and the plant would have begun consuming electricity (at a penalty rate) rather than producing energy (the primary income for the facility is from incinerating waste, and not power generation).

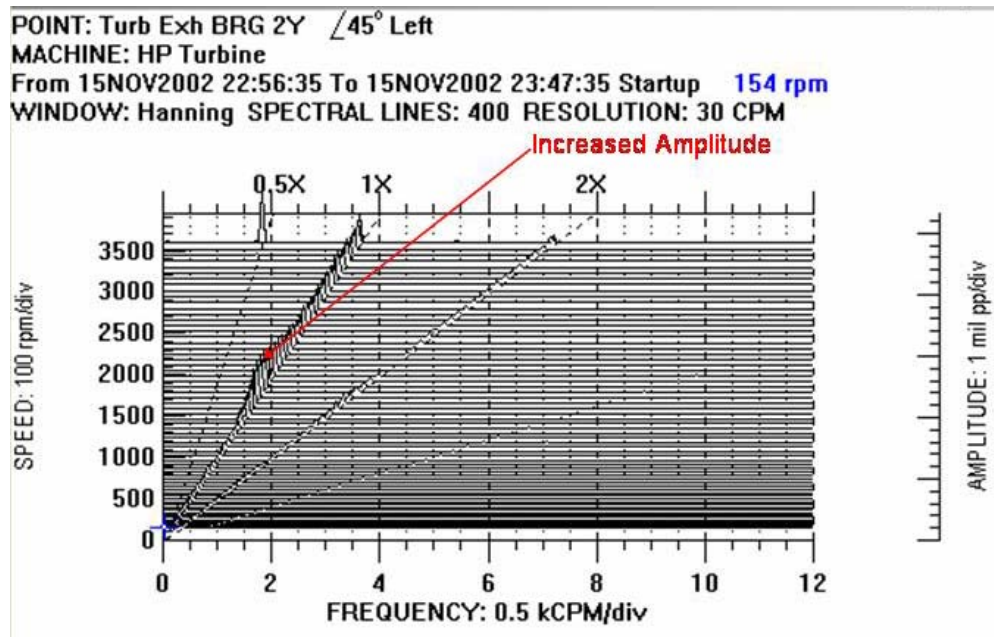
The plant had experienced unusually cold weather the evening before MSI arrived on-site which had triggered one of these vibration events. MSI observed the shaft orbits and vibration spectra using the proximity probes which were installed at each bearing location. The spectra of the proximity probe signals were monitored with high frequency resolution (0.06 Hz resolution) which indicated a strong subsynchronous vibration component which was just below 50% of running speed.

The shaft orbits at the two turbine bearing locations had a secondary loop and

did not have stable amplitudes. MSI arrived the second morning to find that the turbine was vibrating in a similar manner due to an emergency shutdown of one of the two boilers as a result of an unacceptable air pressure differential in the boiler. The characteristics of the vibration were identical to the previous day. The proximity probe vibration spectra during normal operation indicated a rotor critical speed at 49% of running speed.

MSI concluded that the vibrations were due to classic rotordynamic instability. The physical explanation of rotordynamic instability is that the whirl of the rotor, driven by the net fluid swirl forces surrounding it (at slightly less than 50% of the rotational frequency of the rotor), is at a frequency that matches the rotor natural frequency, the rotor no longer responds to the force of swirling pressure fields as soon as those forces are applied, but instead, is delayed by a quarter turn of the rotor's whirl orbit. This response is resisted by the system damping which also acts with a 90 degree phase lag. Essentially, this means that a slight displacement of the rotor will result in forces which act to increase the displacement until the rotor makes mechanical contact with the stationary bearing surface.

- 1) Control the temperature of the lubricant to maintain a sufficiently low viscosity and reduce the cross-coupled stiffness. This recommendation is very simple to implement and requires no hardware changes.
- 2) Change the turbine bearings to break up the fluid swirl. This would require either pressure dam or tilting-pad bearings. This recommendation would require a significant amount of hardware modification including changing the bearings and most likely modifying the bearing housings.
- 3) Modify the rotor to shift the rotor critical speed above 50% of running speed. This involves major changes to the rotor, but would definitely eliminate the rotordynamic instability.
