Dramatic Vibration Improvement due to Ring-Section Pump Foundation Repair Based on ODS in a Power Plant

26th International Pump Users Symposium

Maki M. Onari
Mechanical Solutions, Inc.

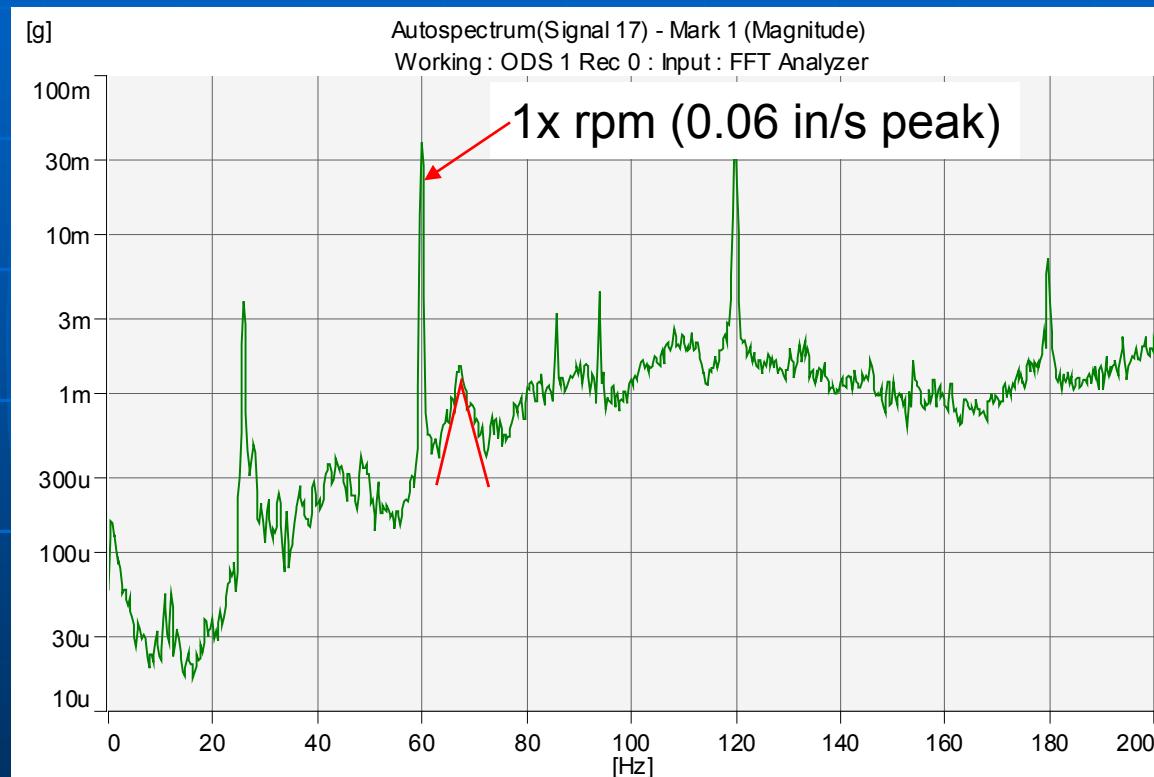
Pump #1 Typical Spectrum OBB in the Horizontal Direction

Natural frequency at 67.3 Hz (12.6% above 1x rpm)

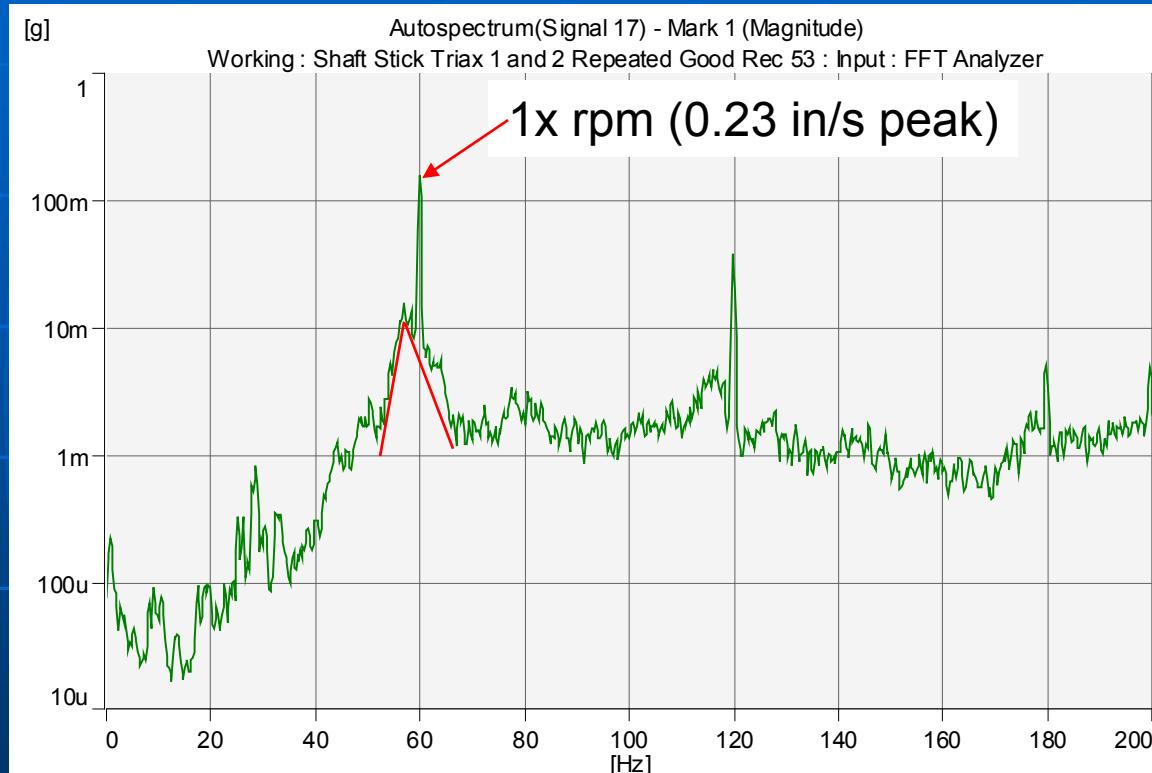
Pump #2 Typical Spectrum OBB in the Horizontal Direction

Closest Natural frequency at 56.8 Hz (5% below 1x rpm)

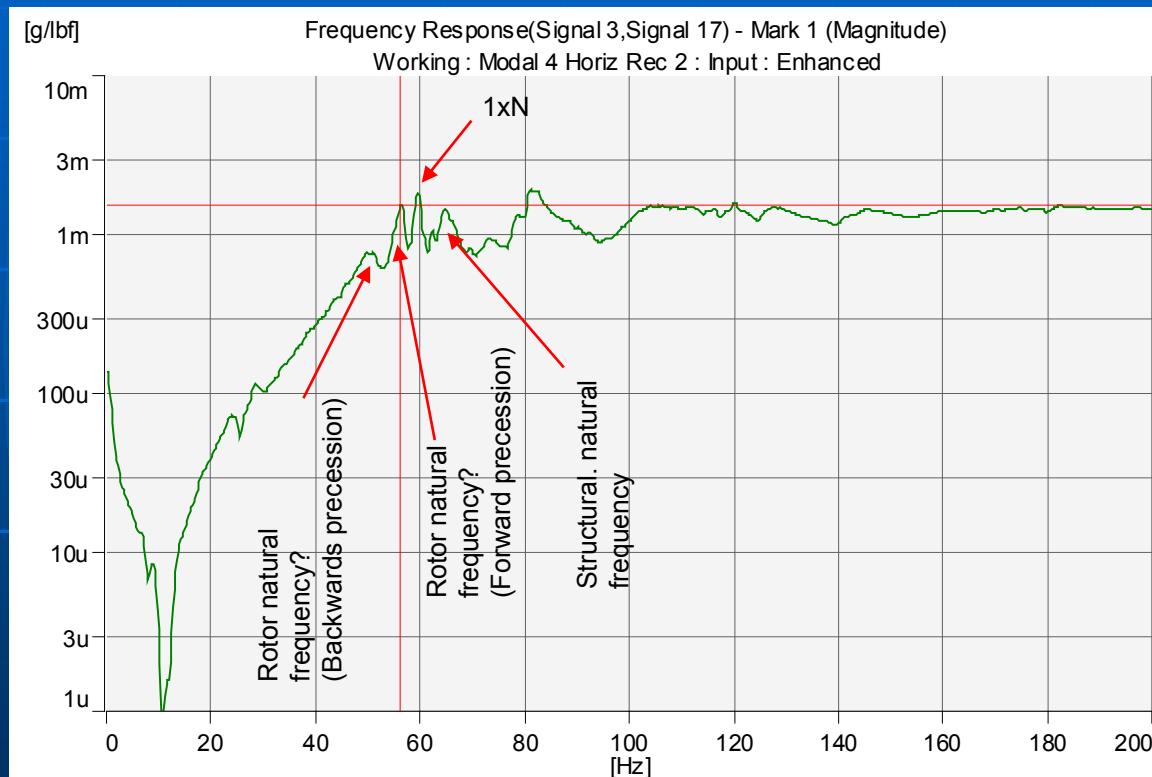
Pump #2 Modal (Operating) Spectrum in the Horizontal Direction at the Pump OBB Housing

Closest Natural frequency at 56.8 Hz (5% below 1x rpm)

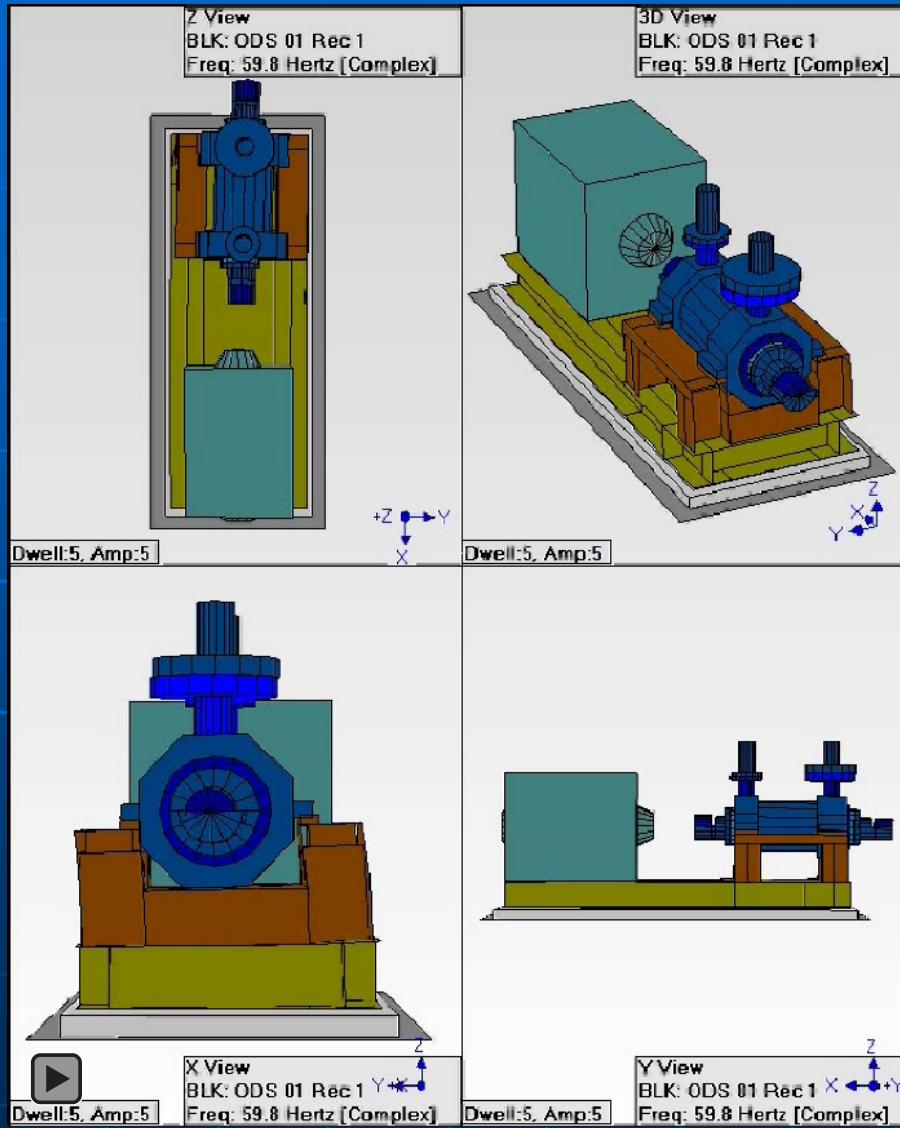
Baseline
data
Pump #2
@ 1x rpm

1. Excessive flexibility at the baseplate due to possible softness or delamination of the internal grout (Pump #2 moved 10x more than Pump #1).
2. OBB housing vibration increased almost 6 times in 4 hours of operation (from 0.06 in/s peak to 0.35 in/s peak @ 1x rpm), and 50% shaft vibration.
3. During the cold start up, 1x rpm spike located between two natural frequencies (57 Hz from the rotor lateral and 63.5 Hz from the structure). The structure became less stiff and reducing the damping of the system; therefore, the rotor natural frequency shifted upwards in the neighborhood of the running speed.
4. Shaft phase angle variation over time. (OBX -60 deg., OBY -20 deg., IBX -110 deg., and IBY -110 deg.)
5. Pumps #1 and #3 did not indicate rotor natural frequencies near the running speed. The lateral rocking mode was identified 13% above 1x rpm.

- 1. Inspect the welding areas of the pedestal and the baseplate for potential cracks.**
- 2. As a short term fix, increase the stiffness of the baseplate.**
- 3. As a long term fix, the baseplate should be re-grouted to assure rigid connection with the foundation and proper structural damping.**

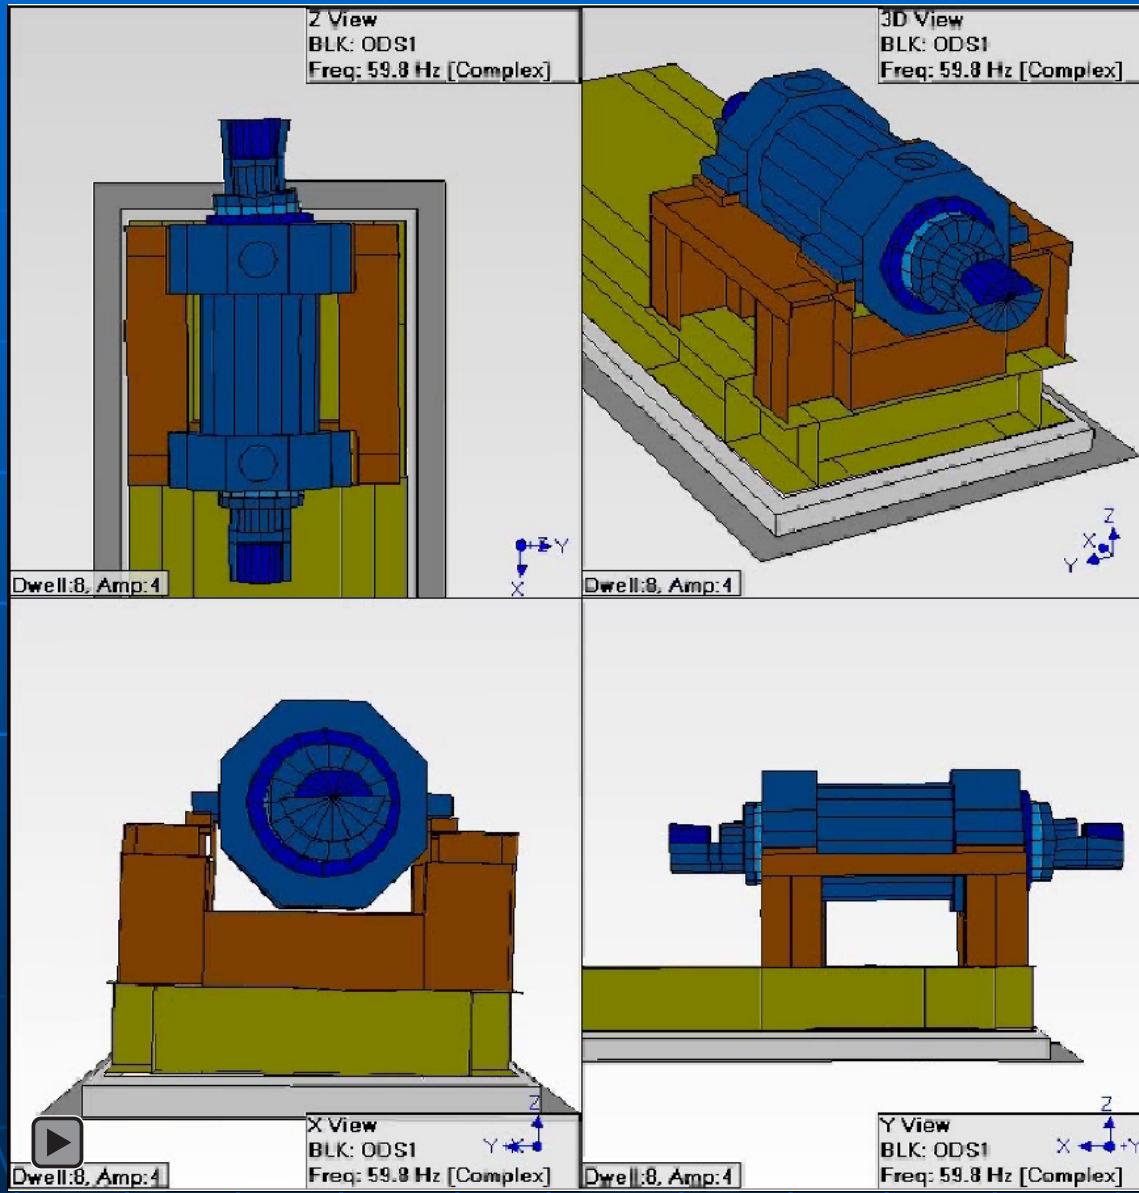
Pump #2 @
1x rpm after
OB feet
bolts
tightened

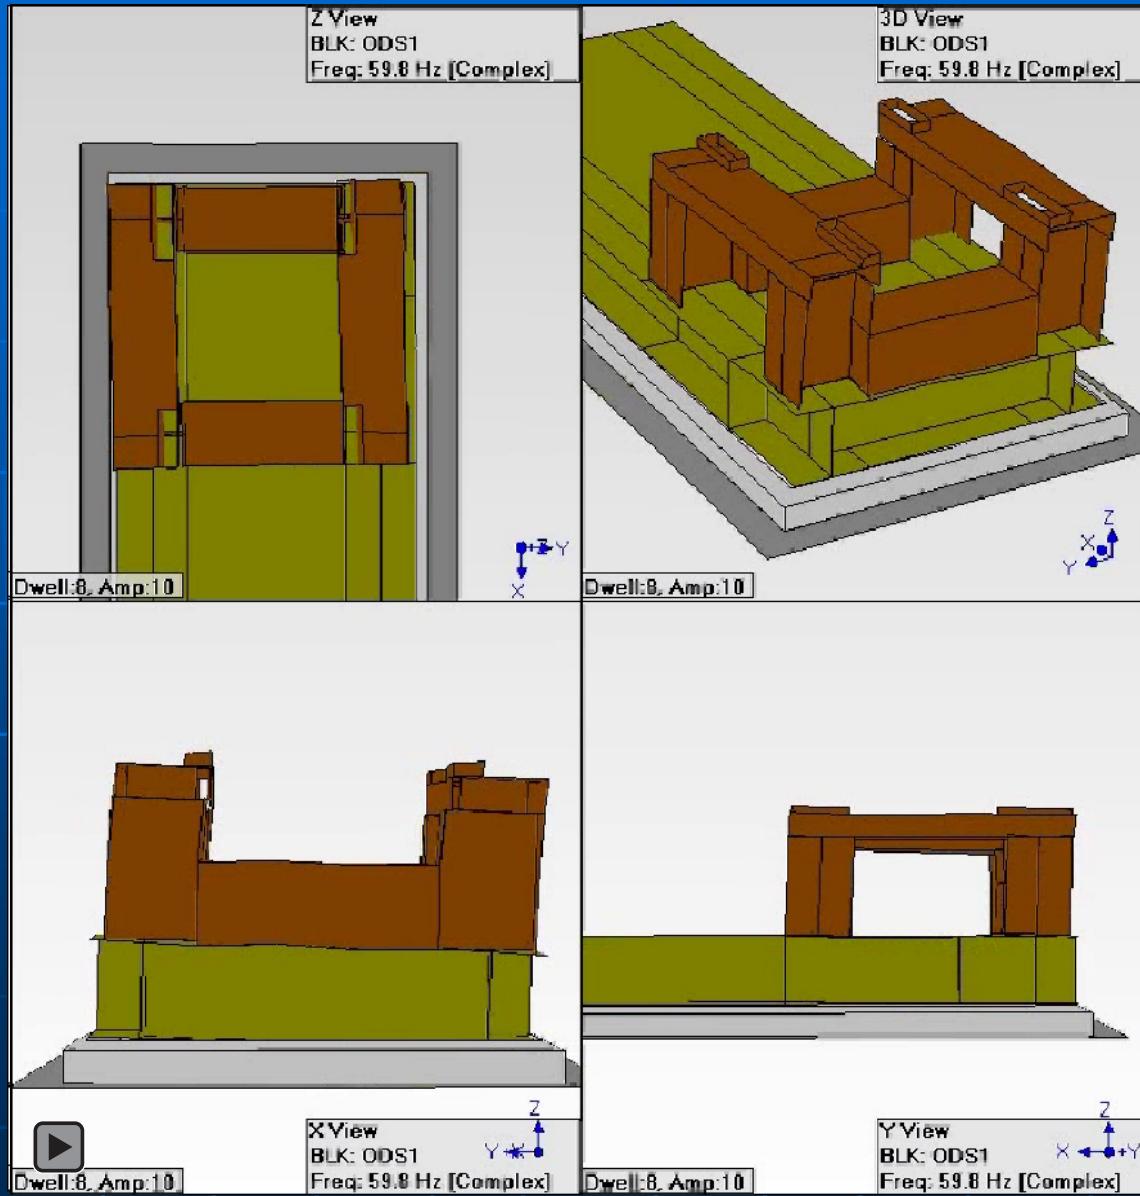
Pump #2 @
1x rpm after
OB feet
bolts
tightened

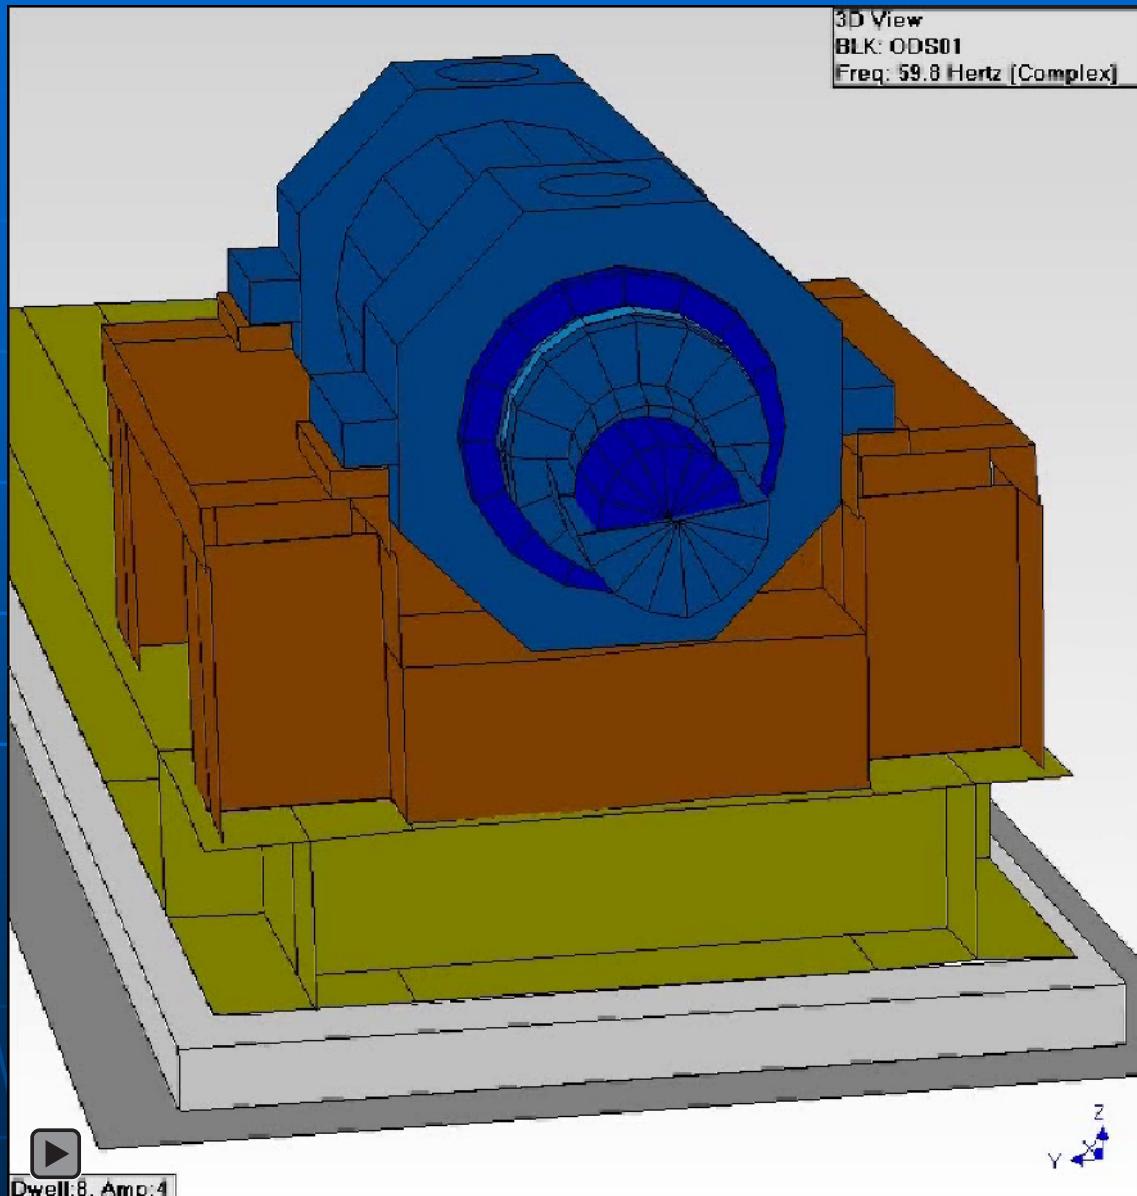
Pump #2 @
1x rpm after
OB feet bolts
and
baseplate
anchor bolts
tightened

- All J-bolts of the baseplate torqued up to 600 ft-lb.
- Pump IB feet bolts torqued up to 1000 ft-lb.
- Dowel pin and holes cleaned up and drove pins in tight.
- Pump OB feet tightened after full warm-up condition

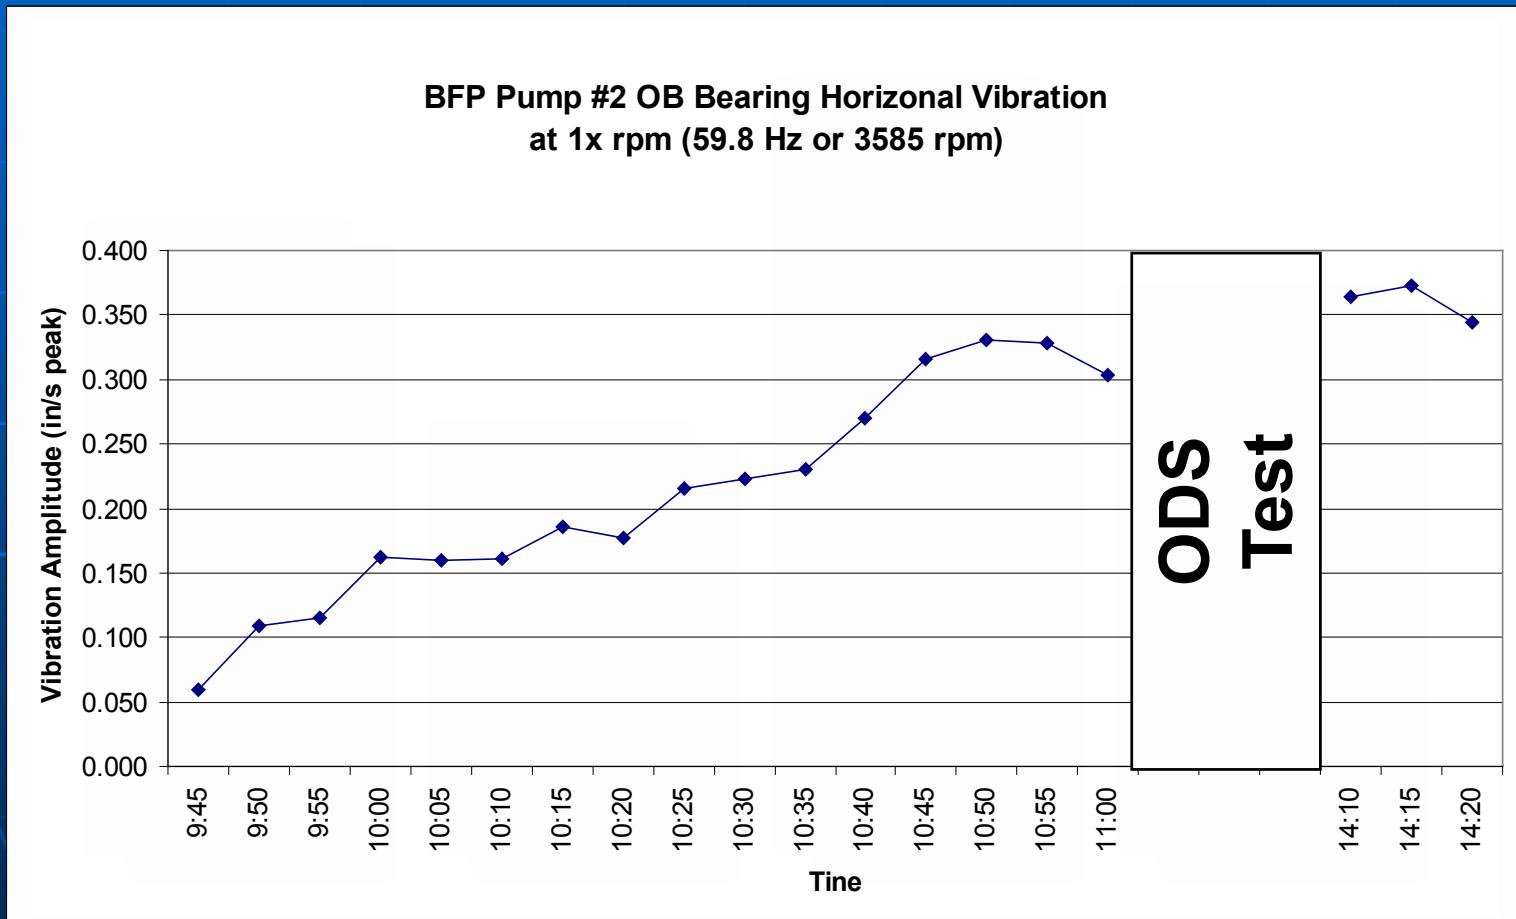
Pump #2 OBB Housing Vibration Trend in the Horizontal Direction

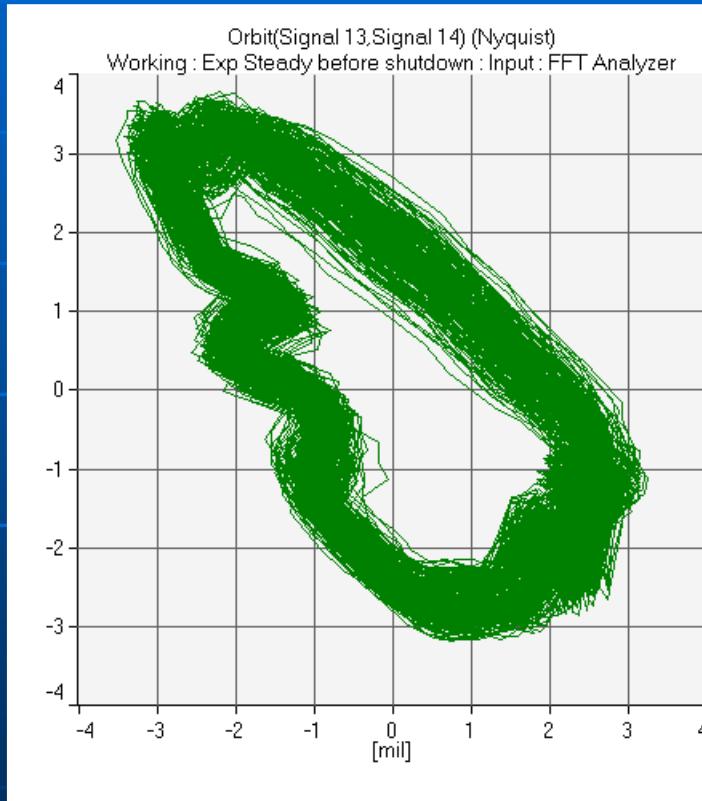
OBB

6.5 mils pk-pk

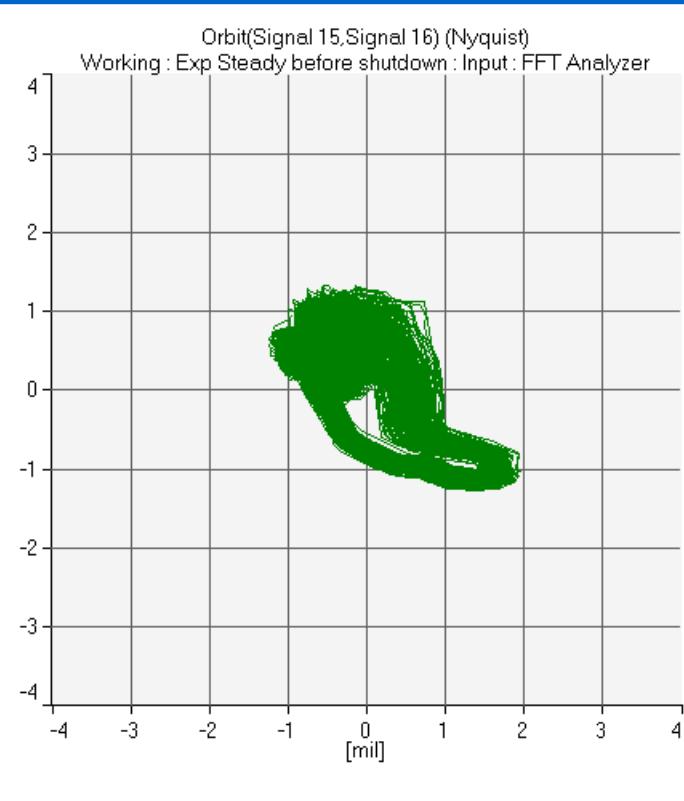
IBB

2.5 to 3.0 mils pk-pk

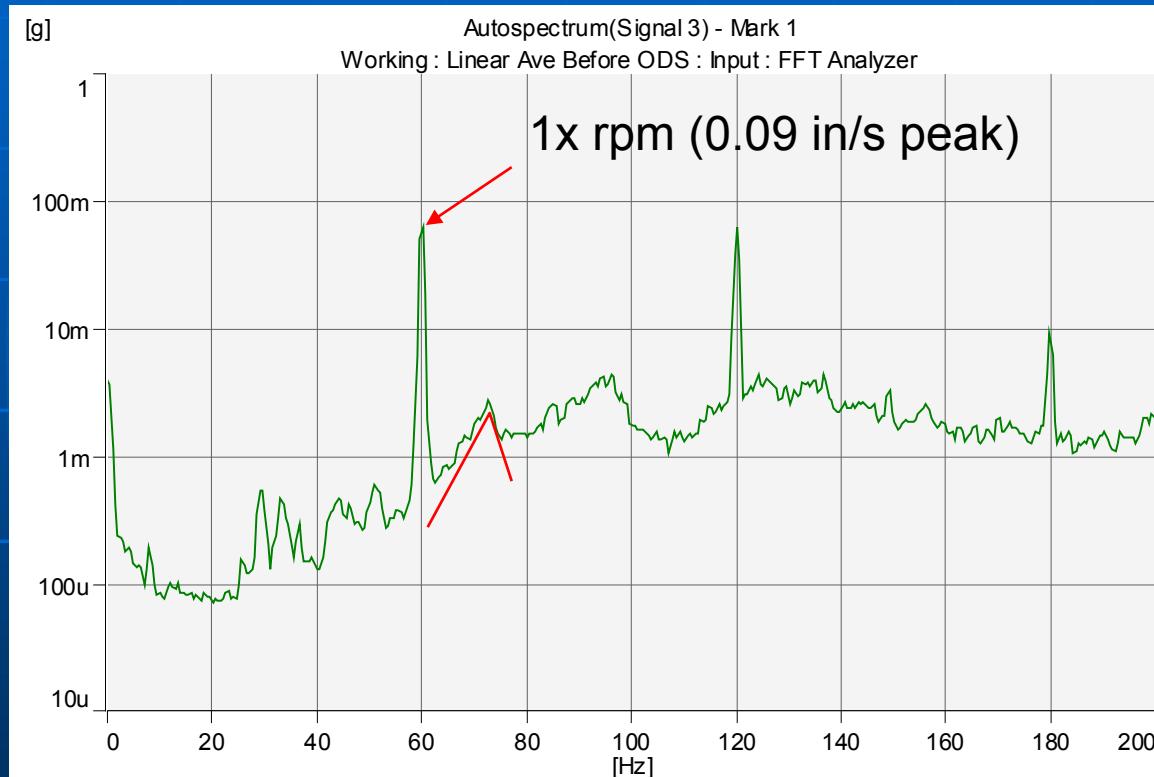
Pump #2 Typical Spectrum OBB in the Horizontal Direction After Implementing Modifications

Natural frequency at 73 Hz (23% above 1x rpm)

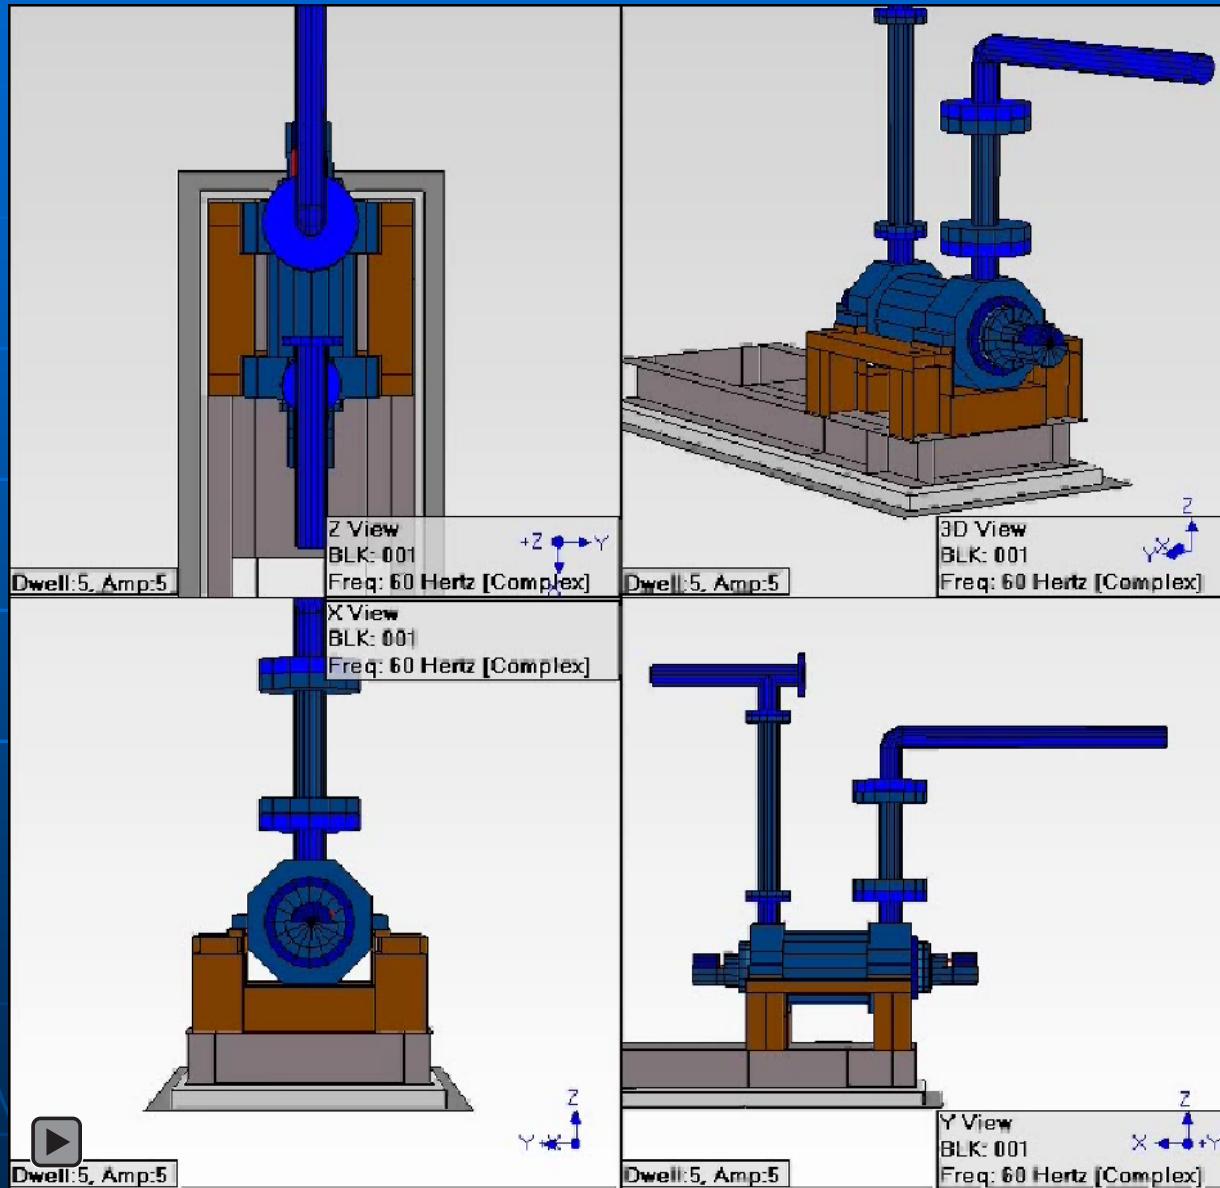
- The root cause of the vibration on Pump #2 was due to excessive flexibility at the baseplate caused by softness or delamination of the internal grout. This phenomenon originated due to the looseness of the anchor J-bolts.
- After all modifications performed on the baseplate, the maximum vibration amplitude at the OBB housing in the horizontal direction was reduced from 0.35 in/s peak to a greatly improved value of 0.09 in/s pk @ 1x rpm.
- The ODS is a powerful troubleshooting tool to facilitate and visually understand most common vibration problems in any pumping system or turbomachine.
