Case History: Hydro-cracking Pump Rotor Failures

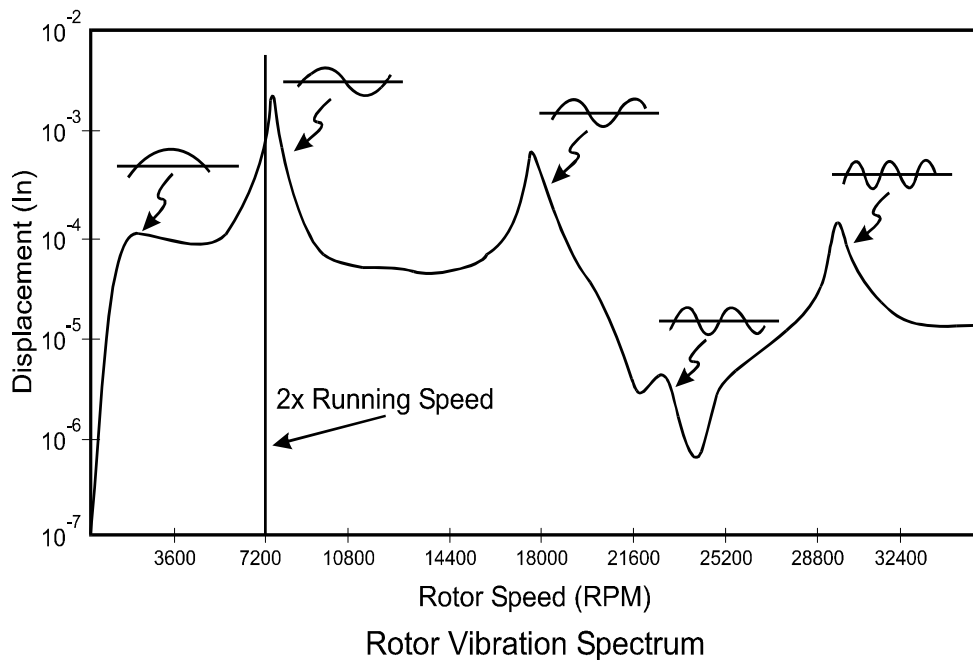
Impact testing was used to determine the reasons for three failures of a hydrocarbon cracking pump which was critical to a diesel fuel production process at a major California refinery. Each failure closed down or severely curtailed fuel production at the refinery, at an average cost of about \$3/4 million per day. Vibration testing was used to determine the shaft critical speeds while the pump was operating at various loads and with various product densities and viscosities. This allowed a rotor dynamics analysis of the 11 stage flexible shaft pump to be calibrated by the test results, so that the analysis could then be used to accurately predict why certain operations in the process might have caused pump failure, and whether proposed rotor changes would avoid future problems.

The testing found the critical speeds of the operating pump, and the combined testing and analysis showed that the main reason for past failures was a poorly damped backward precessional rotordynamic critical speed, which was located at a lower speed than expected. The critical speed would be excited operationally at 2x running speed during a rub of the balance piston. This was possible when pumping product with excessively low specific gravity, because of flashing of the liquid at the exit of the balance drum causing loss of a liquid film between the rotor and stator. A time-averaged pulsing
