Case History: Urea Screener Failure Problems

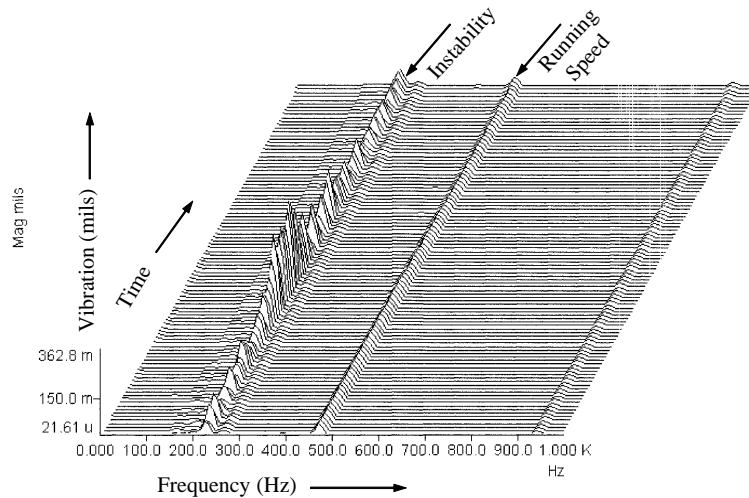
The OEM attempted to modify the bearings to reduce the pad temperatures but this was unsuccessful due to unacceptably high vibration amplitudes. Following the vibration trips MSI traveled to the facility on very short notice and began testing. The data collection involved a series of process and bearing oil tests to recreate the trip phenomena. MSI was able to conclusively

identify the problem as a rotordynamic instability caused by a strong subsynchronous excitation of a cantilevered rotor natural frequency located at 47 percent of running speed (refer to figure). Rotordynamic analysis suggested that the subsynchronous excitation was due to labyrinth seal cross

coupling effects. Based on the recommendation of MSI, the manufacturer installed swirl breaks to decrease the subsynchronous vibration excitation. This eliminated the rotordynamic instability and allowed the bearings to be modified in order to reduce bearing pad temperatures. Following the installation of swirl breaks the machine has not experienced a vibration related trip.
